# Observations of Flaking of Co-Deposited layers in TFTR

C. H. Skinner, C. A. Gentile, and K. M. Young  
Princeton Plasma Physics Laboratory, Princeton NJ 08543

*Abstract*-Flaking of co-deposited layers in the Tokamak Fusion Test Reactor (TFTR) has been observed after the termination of plasma operations. This unexpected flaking affects approximately 15% of the tiles and appears on isotropic graphite tiles but not on carbon fiber composite tiles. Samples of tiles, flakes and dust were recently collected from the inside of the vacuum vessel and will be analyzed to better characterize the behavior of tritium on plasma facing components in DT fusion devices.

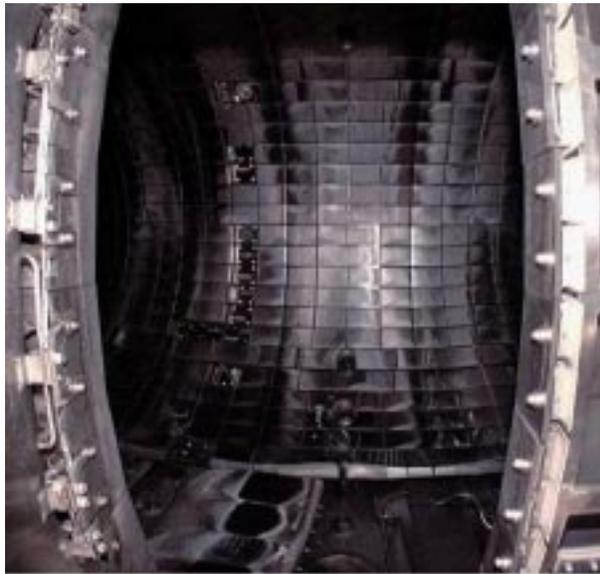
Fig. 1 Overview of bumper limiter bays L, K, J. Some tiles have been removed from Bay L on the left. 990014-01

on the lower part of the bumper limiter and some unflaked areas showed blistering and corrugation (see Figs. 1 and 2). At the next opening in January 1999 the upper part of the limiter also showed flaking (Fig. 3). The flaking affects approximately 15% of the tiles and appears to occur only on isotropic AXF-Q tiles and not on carbon fiber composite tiles. White deposits are evident near diagnostic penetrations on the lower Bay K bumper limiter and heavy deposits are apparent on the poloidal limiter tiles at the floor of the vessel (Fig. 4) [16].

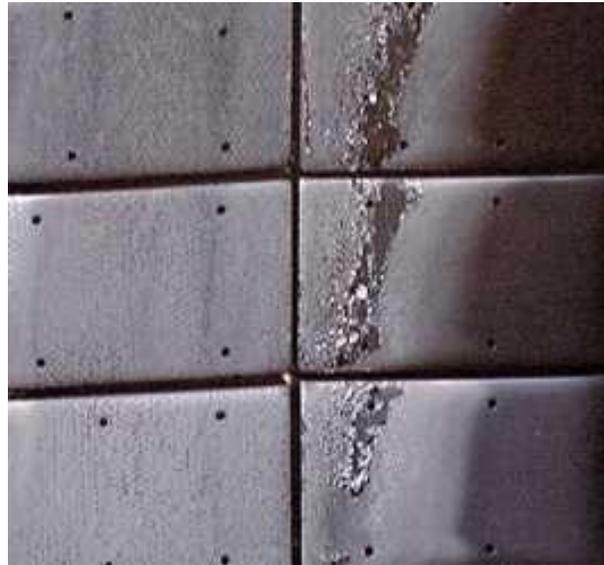
Fig. 3 Flaking at the top of Bay K. Note the CFC tiles on the left do not show flaking. 99E0023-09

Since flaking occurs on some tiles and not others, it is important to identify the factors leading to flaking. One factor is the tile material - no flaking is observed on carbon fiber composite (CFC) tiles. Possibly the surface texture on CFC tiles facilitates better adhesion of the co-deposited layers. The thickness of the co-deposited layer may be another factor. The source of the co-deposited material is

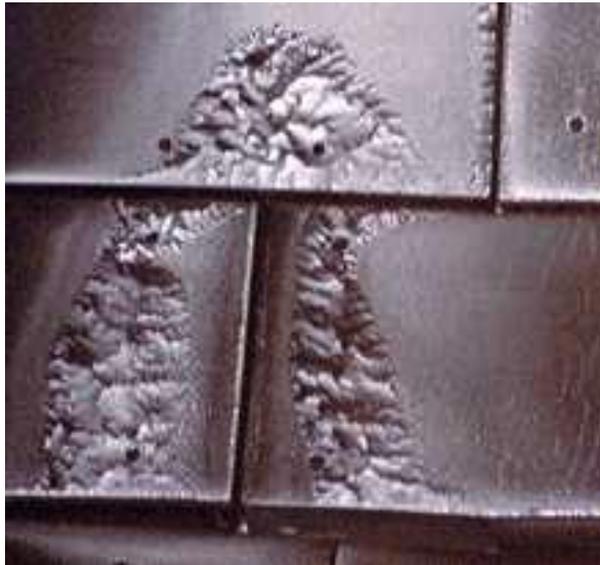
Fig. 2 Close up of blistering at lower part of Bay K. The vertical height of a tile is 81 mm. 990023-23

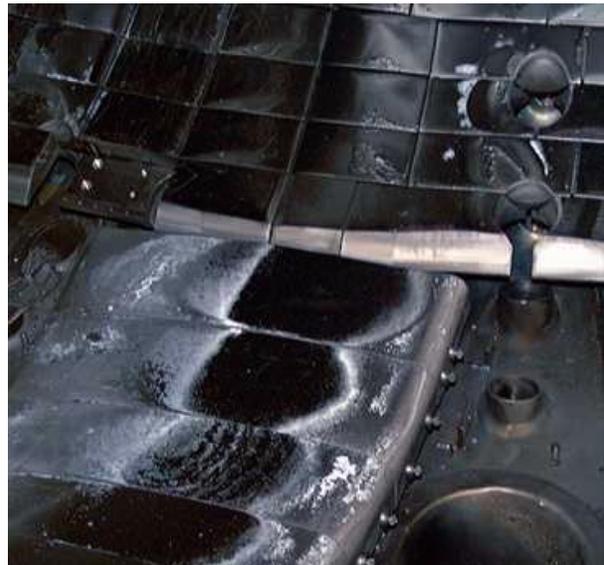
Fig. 4 White deposits on the bumper limiter near a diagnostic penetration (upper right) and on the poloidal limiter tiles on the floor. 00E0022-09

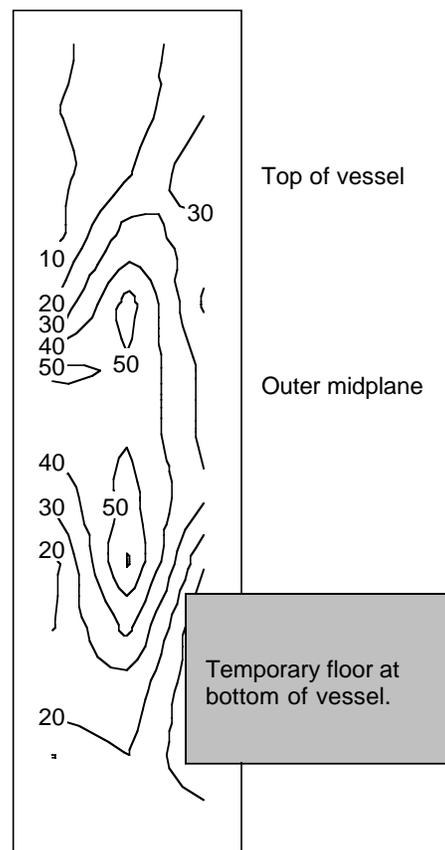
Figure 5. Contour plot of near surface tritium on poloidal limiter between Bays K/L in μCi/cm<sup>2</sup>. This plot is interpolated from measurements on a 3 x 13 grid.

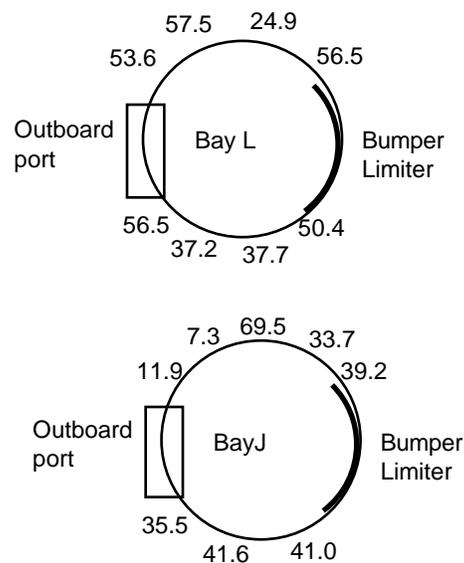
Figure 6. Ion chamber measurements of surface tritium on the vessel wall at Bays L and J in μCi/cm<sup>2</sup>. The approximate location is shown schematically.
